# Manhole Inspection Summary

Manhole # S33KK1016MH

Insp Date: **2/28/07 11:01 AM**

**Location** Address: **MILBROOK RD**

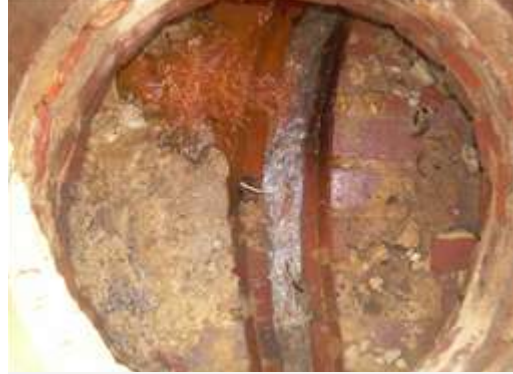
Top View

Bench debris.

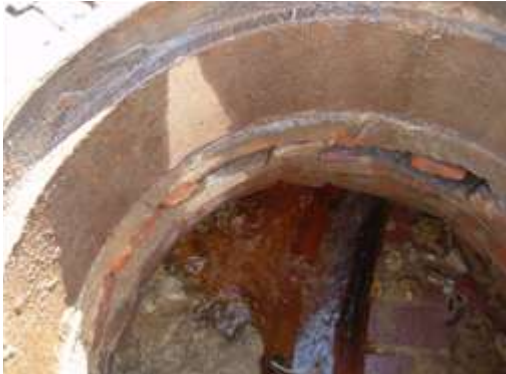
Defect

**Frame** Offset: **0** (in.) Condition: ☐ Sound ☐ Cracked ☒ **Leaks**

Condition: ☐ Sound ☐ Cracked ☐ Root Intrusion ☒ **Loose Brick** ☒ **Deteriorated**

Infiltration: ☐ None ☒ **Joint** ☐ Cracks ☐ Mortar ☐ Roots ☒ **Wall**

Frame leaks. Adjustment deterioration, loose brick and infiltration.

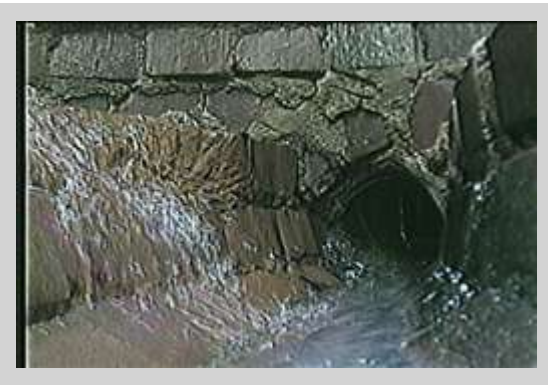
### 6 in. Circular Gravity Sewer Pipe Out @ 12 O'Clock

Channel deterioration.

Infiltration: **Evidence** Pipe Seal Cond: **Broken**

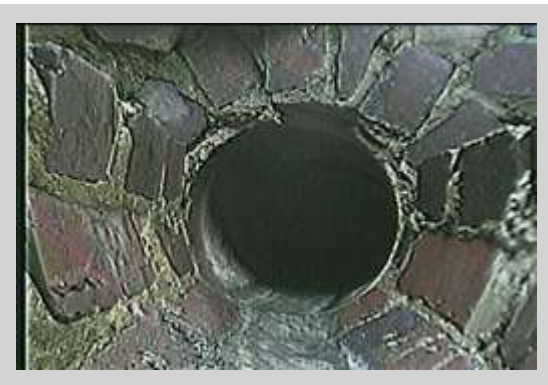
### 8 in. Circular Gravity Sewer Pipe In @ 5 O'Clock

Infiltration: **None** Pipe Seal Cond: **Broken**

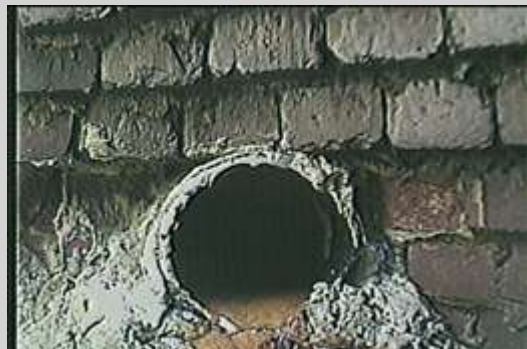
Pipe In @ 9 O'Clock

Barrel deterioration and infiltration.

Infiltration: **Evidence**

Pipe Seal Cond: **Broken**
